**DISASTER RECOVERY
CONSERVATION OF FIRE DAMAGED COLLECTION**

Client
Private Collection
Reference available upon request

Location
Kerrville, Texas

Project Dates
2012

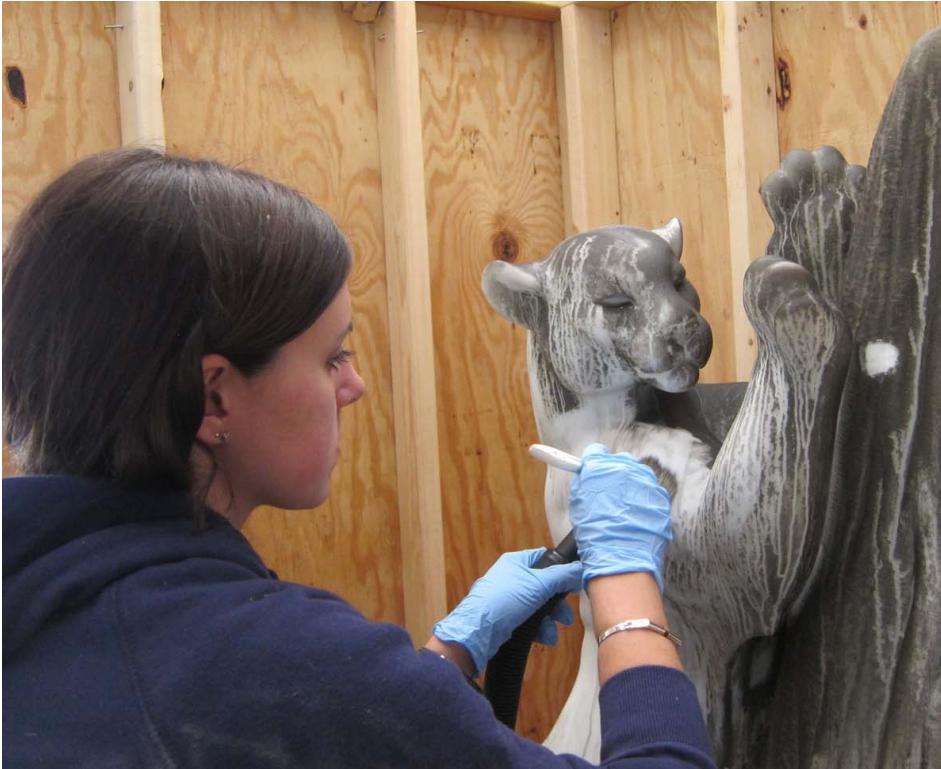
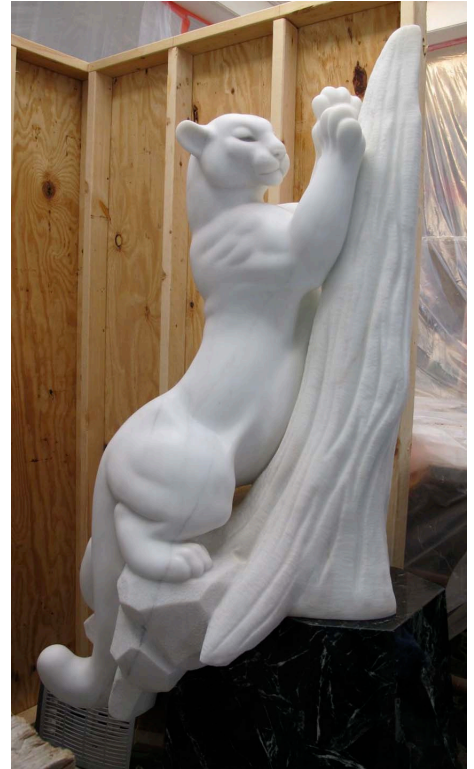
RLA was contacted through a fine arts insurer to undertake the treatment of 24 sculptures and decorative artworks affected by a residential electrical fire. Consisting of marbles, bronzes, silver pieces, porous ceramics, and geodes, the works were covered with a thick layer of carbonaceous debris and soot. Some of the works had absorbed oily residues from charred materials. Removal of the soot and debris was performed in stages, beginning with vacuuming, followed by dry cleaning with polypropylene and soot sponges, ending with removal of wax coatings on the bronzes and solvent and detergent cleaning of geodes, marble sculptures, gilded metals, and porcelains. The conservation sequence was followed by a final report documenting each artwork's details, treatment performed, and recommendations for storing and maintenance.
