PAINTED CONCRETE SCULPTURE- MERMAID BY ROY LICHTENSTEIN

Client
City of Miami Beach Department of Art in Public Places

Piece
Mermaid

Services Provided
Assessment, stabilization, temporary treatment, maintenance

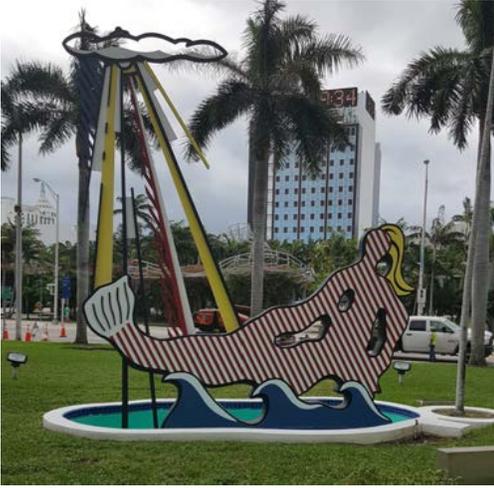
After Treatment

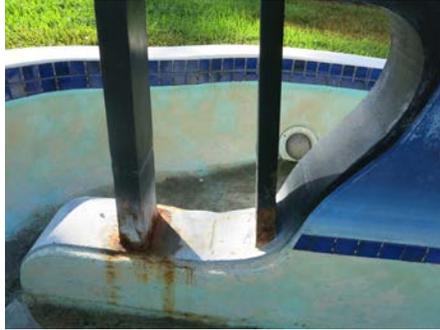
Before Treatment

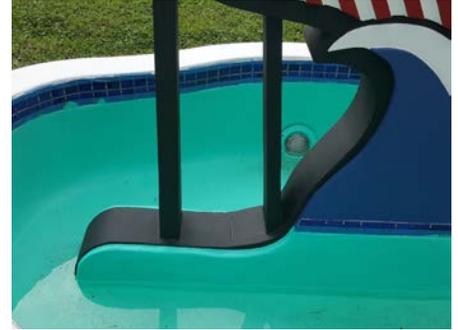
After Treatment
