## HISTORIC ARCHITECTURE CONSERVATION STONE BALCONY - CORAL GABLES CITY HALL

Building  
Coral Gables City Hall

Project Dates  
May – June 2015

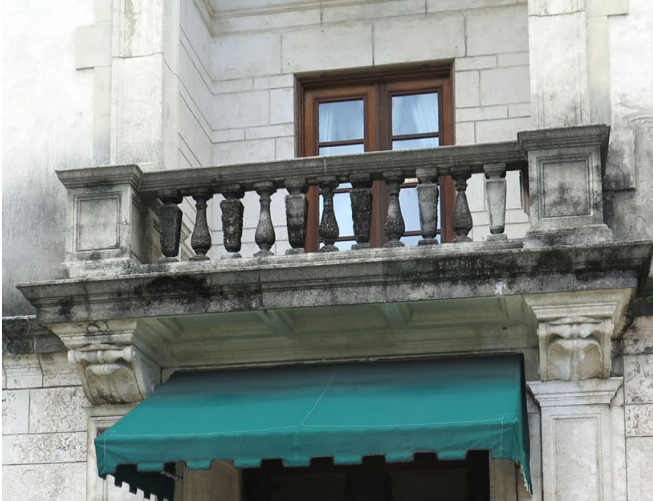
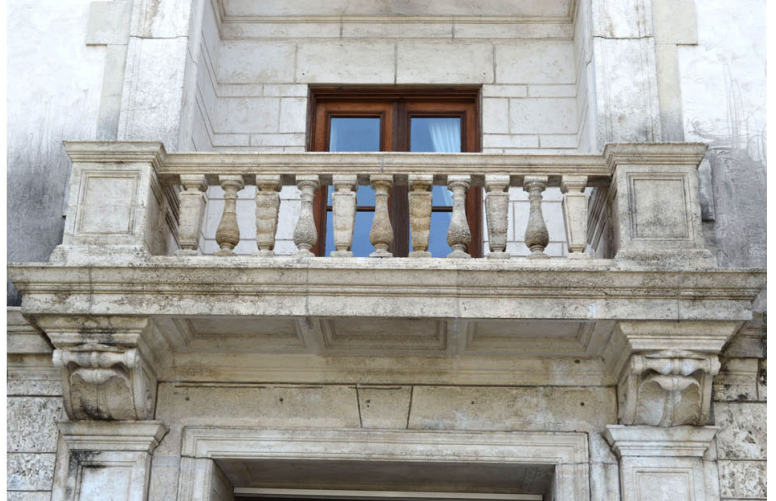
Coral Gables City Hall is a Mediterranean Revival building on the National Register of Historic Places. RLA has performed several cycles of treatment on this building. This phase consisted of cleaning, fungicidal treatment, emergency stabilization, consolidation, and loss compensation on cast stone decorative elements at the roofline and Mayor's Balcony levels. The roof level urns and finials were of particular concern, as they had been found to be loose in a 2014 RLA-led building-wide survey of City Hall's decorative features.

Our firm also provided all hands-on services to secure and stabilize the urns, finials and decorative architectural relief panel and balusters on the Mayor's Balcony. Working with limited funding provided by a grant, we identified the most critical areas for repair of the exterior and cleaned the stone, removed fungal growth and grime, stabilized fragmenting and crumbling areas, removed concrete and epoxy repairs, stabilized corrosion, and compensated losses in these areas.
