ARTIFACT & DECORATIVE OBJECT CONSERVATION
DECORATIVE AND PROPAGANDA ARTS

Client
 Wolfsonian Museum
 Florida International University

Object
 Model Greyhound Bus

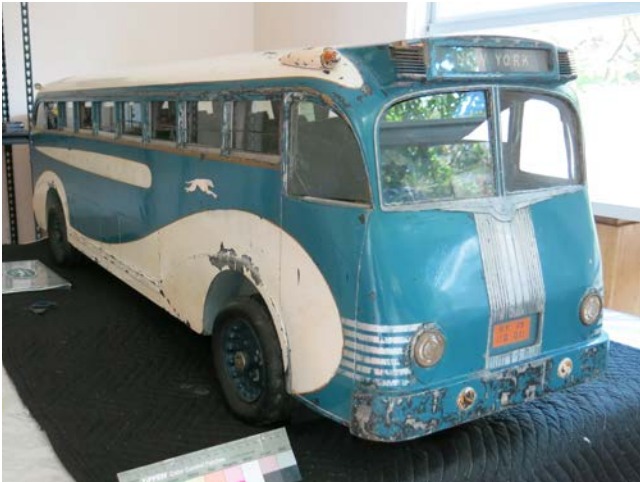
Before Treatment, overall

This object is a scale model greyhound bus fabricated of painted aluminum on a steel chassis with two axles. The bus is fitted with six rubber wheels and the interior has model seats made of wood and upholstered in fabric. RLA was retained by the Wolfsonian to mitigate insect damage and conserve the model. Evidence of insect activity in the form of frass was detected during initial inspection and the bus was subjected to anoxia fumigation for 6 weeks, a process that suffocates insects using oxygen scavengers in an airtight chamber. Afterwards, we determined how best to address the overall conservation of the model. A decision was made to stabilize the damaged wheels and chassis and repair losses to the metal and exterior paint layer to render the object able to stand without crushing its wheels. A system for supporting the weight was fabricated and installed. The metal was cleaned of minor corrosion and old repairs were removed. Interior fabrics were repaired and re-adhered to the walls and roof of the bus and the exterior was filled and inpainted. The aim was to produce a work that was stable and able to be seen as a decorative object.

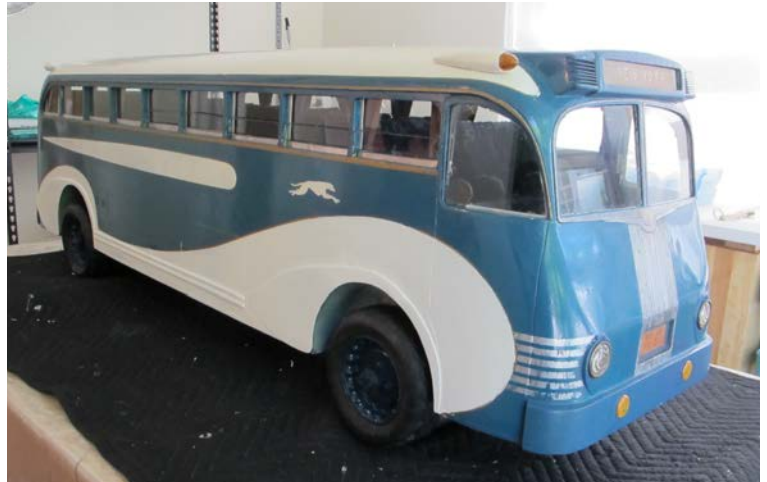
After treatment, Overall
